HUNTER'S HILL HERITAGE STUDY: SUB-CONSULTANTS' REPORTS

WATERFRONT WHARF STRUCTURES

MEREDITH WALKER & ASSOCIATES.

November, 1983.

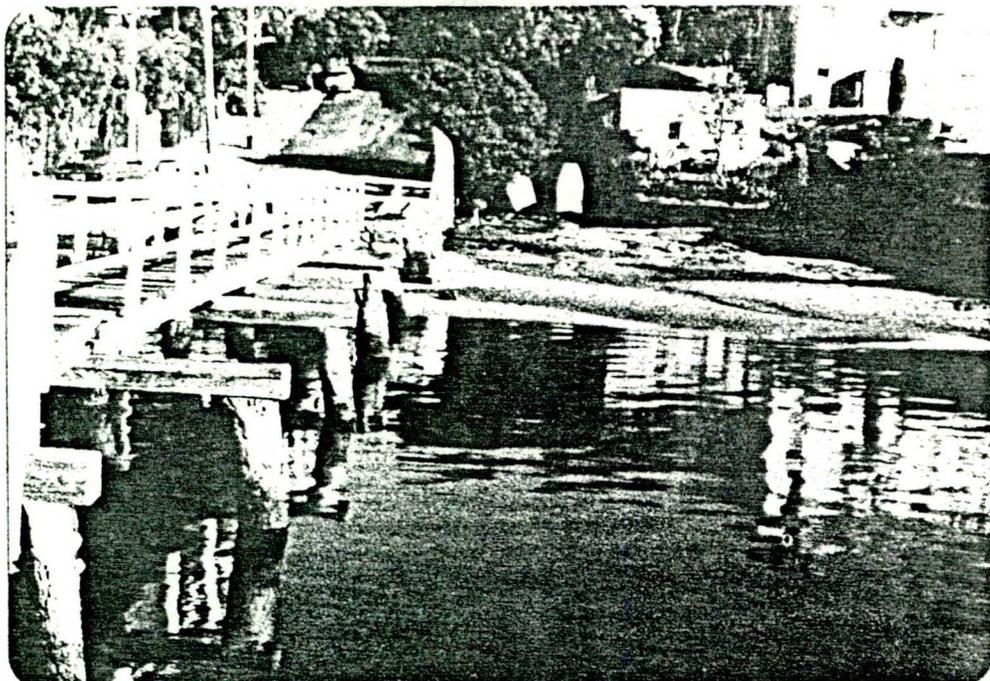
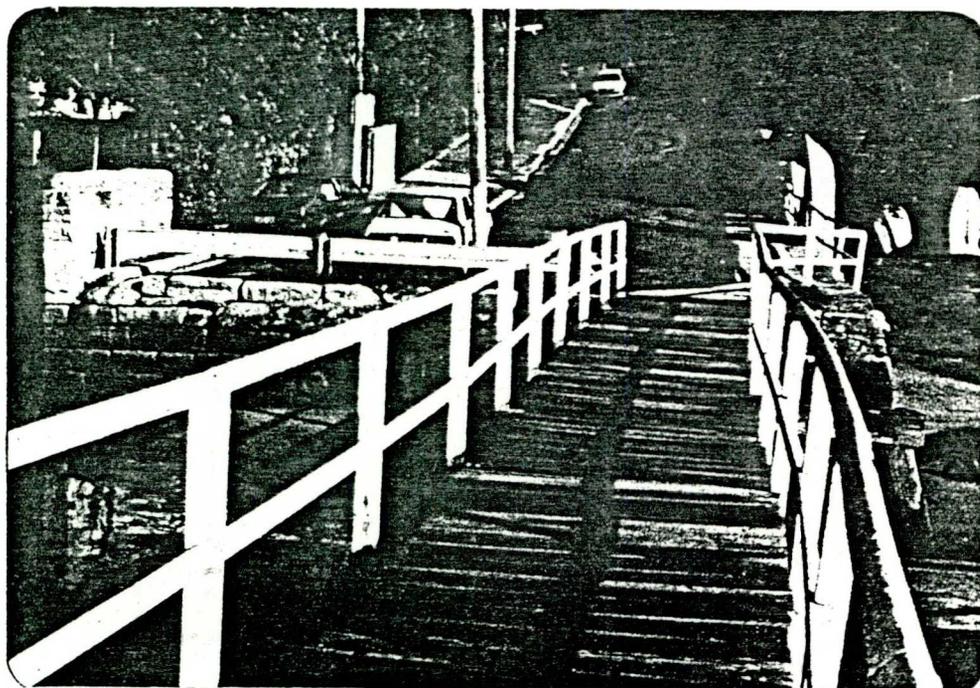
ALEXANDRA STREET WHARF

The Alexandra Street Wharf is a timber structure still in serviceable operating condition. Its substructure, consisting of timber pile "bents" with two raking piles and headstock, is obviously old and exhibits in some cases excessive damage at the wind/water line. The superstructure is more recent and occupies only half the available width of the head stocks. The stone structure is a low stone sea wall retaining the end of Alexandra St. against a sandy beach. The wall is old and probably dates back to the time of the original wharf construction.

Timbers in wharf construction, especially the substructure has a limited life and during the serviceable life of the structure must be continually replaced. The usual life of turpentine piles is between 15 and 30 years, although some timbers are known to have lasted well in excess of 50 years. It is not unusual to try to extend the life of piles by wrapping them in copper or muntz metal sheathing (early technique) or encasing them in concrete (later technique). Some of the piles on the Alexandra St. Wharf have been treated with copper sheathing, some with concrete casing, and others remain untreated. There is serious decay in some piles.

The timber structure is currently in service although only superficial maintenance has been applied to it in recent years. Much of the sub-structure needs attention including some piles which need replacement. Unless there is a special agreement between Council and the M.S.B. vesting interest in the wharf to Council it would be the Board's responsibility to maintain the wharf. We would expect an annual budget of up to \$5000 would be required to ensure the continued existence of the wharf.

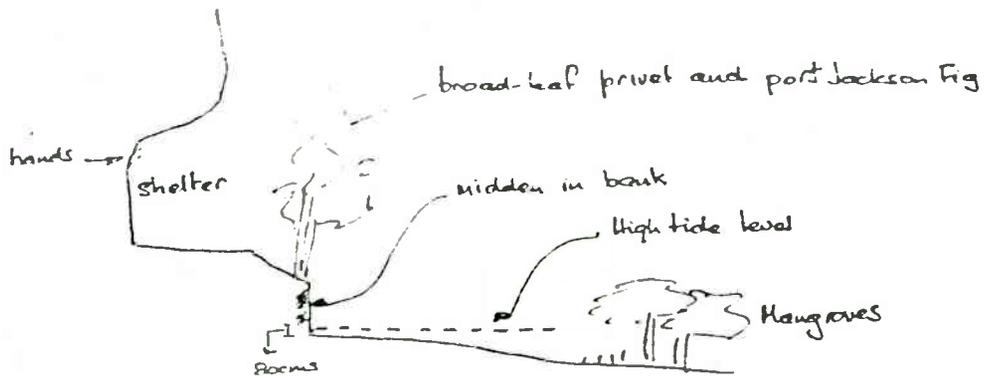
Schematic cross-section
not to scale

Site[Ⓢ] is located in cliff at point where mangroves are growing (about 120 metres from boat-shed); shelter is obscured to a certain amount by vegetation and is about 2.5 metres above ground covered by high tide. From bottom of bank the first indication we saw of the site was an exposed section of deep midden in the bank about 80 cms above the ground covered by high tide.

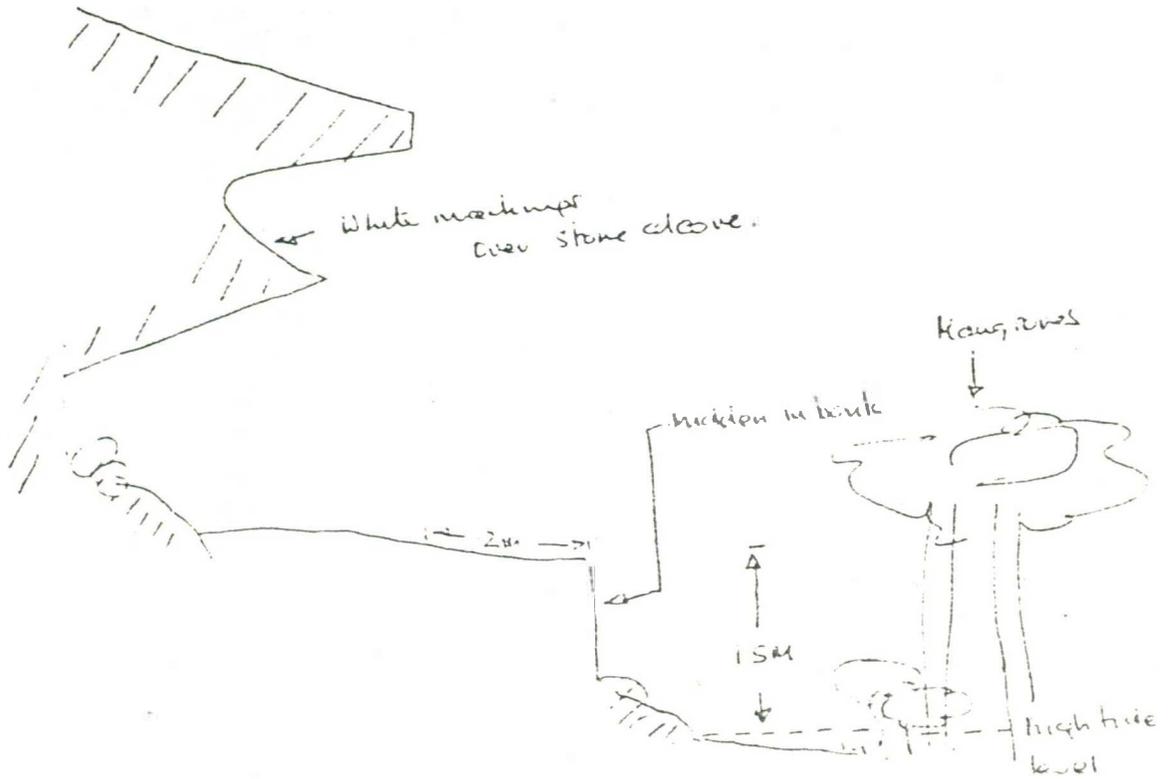
SHELTER WITH MIDDEN AND (ART ?)

Schematic cross-section.
